Utfärdare Issued by Aussteller	Bertil Nyström	Datum Date Datum	2006-07-06	Produkt Product Produkt	Scando hoist accessories
Från maskin nr. From machine No. Von Maschine Nr.	-	Till To Zu	-	Berör/Concerns/Betrifft	Vertical pipe joint

Part No. 0385436-SUB

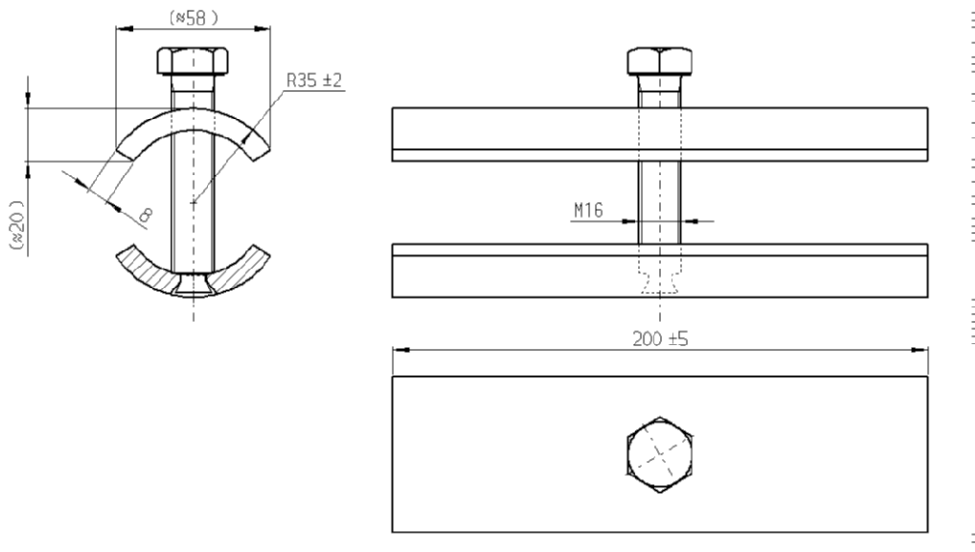
It is important that the joints for the vertical pipes are in good condition.

If not, the joints may break or the mounting and dismantling may take much longer time.

See sketch below for dimensions:

- Check the main dimensions
- Check possible deformations
- Ensure that threads on screw and clamp-half are not damaged
- Check that surface treatment on screw and clamp halves is OK.
- Grease and oil thread on screw and clamp half

If the components do not have the right dimensions, are damaged or corroded, the entire component shall be scrapped.
