SERVICE INSTRUCTION MS 14-2009E

Utfärdare Issued by Aussteller Bertil Nyström	Datum Date Datum 2009-09-22	Produkt Product Produkt Scando 450 and Scando 650
Från maskin nr. From machine No. Von Maschine Nr. All	Till To Zu -	Berör/Concerns/Betrifft Cage door magnet

Information about cage door magnet, with part No. 3002143-103

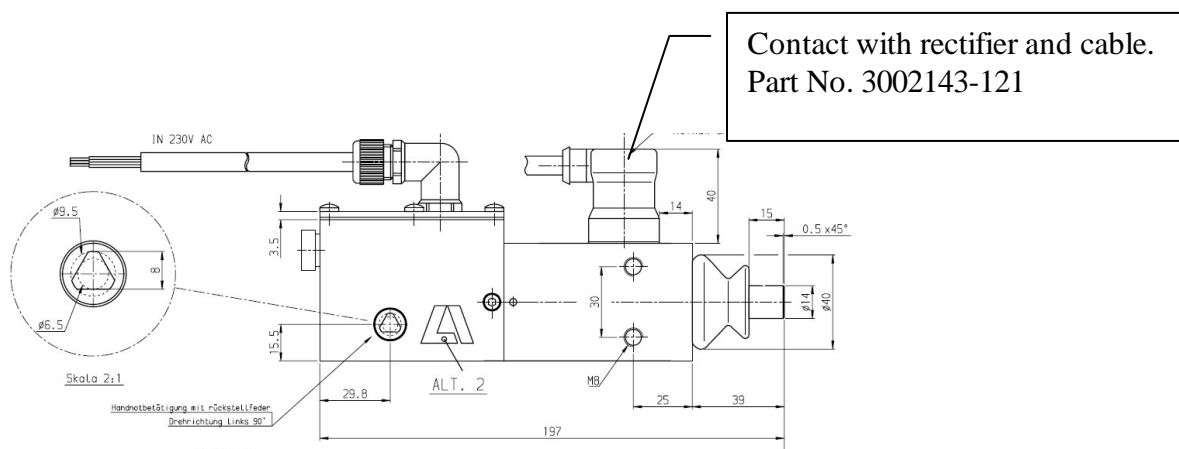
On certain occasions malfunctions have occurred on this magnet. The reason for this was that the contact with the built-in rectifier on the magnet was burnt.

On newer magnets a new contact with rectifier and cable has been applied. The part No. 3002143-121 is the same as before.

The new contact has a better electrical insulation and resists larger voltage variations.

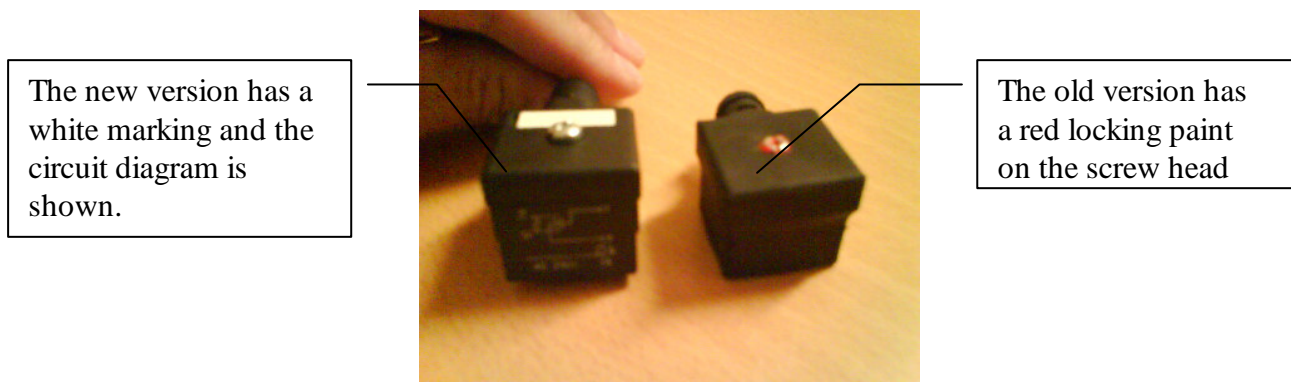
Visible differences between new and old version :
